Water Compliance Inspection Report

Name and Location of Facility Inspected (For industrial users discharging to POTW, also include POTW name and NPDES permit number) Ershigs, Inc. 742 Marine Drive Bellingham, WA 98227	Entry Time/Date 8:15AM 11/19/15	Permit Effective Date 01/02/2015
	Exit Time/Date 1:15PM 11/19/15	Permit Expiration Date 12/31/2019
Name(s) of On-Site Representative(s)/Title(s)/Phone and Fax Number(s) Scott Strickler - Material Administrator/ Env. Safety (360) 527-3437	Other Facility Data (e.g., SIC NAICS, and other descriptive information) 326199 Plastics Product Manufacturing 48.768633 -122.519312	
Name, Address of Responsible Official/Title/Phone and Fax Number Scott Strickler - Material Administrator/ Env. Safety (360) 527-3437 P.O. Box 1707 Bellingham, WA 98227	Contacted <input checked="" type="checkbox"/> Yes <input type="checkbox"/> No

***National Pollutant Discharge Elimination System
(NPDES) Inspection Report***

***Ershigs, Inc.
NPDES # WAR000048***

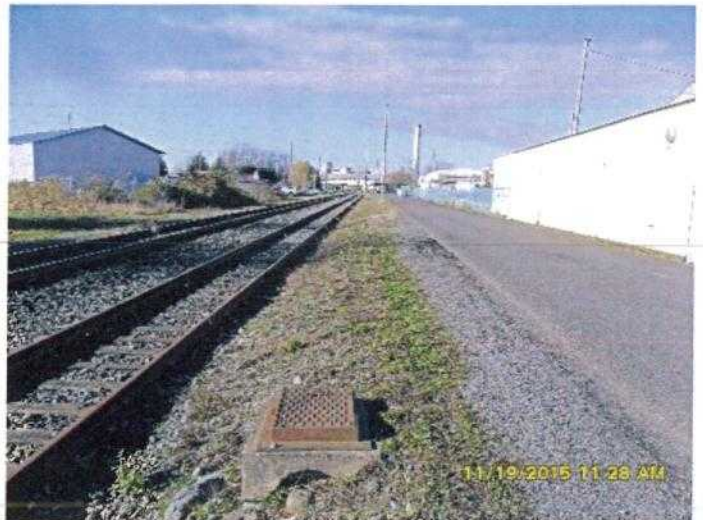
Photo #:02

Description: Westerly view along the south side of the facility.
Photographer was standing near the southeast corner of the property. Camera photo # SAM 2218.

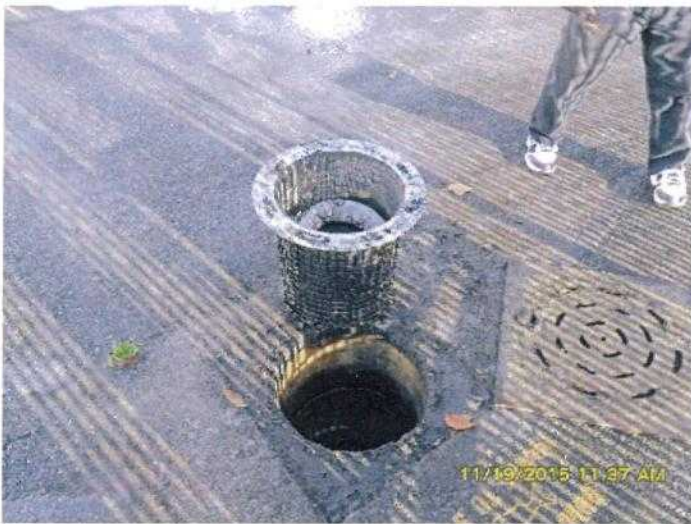
Photo #:03

Description: View of catch basin insert for the catch basin located near the southeast corner of the property. Camera photo # SAM 2224.

- Installation of "ADSORB-it" stormwater catch basin filters with zeolite and carbon treatment media. According to Mr. Strickler, the facility purchased and installed 5 catch basin filters with zeolite media in April of 2015.

Upon receiving sample results back from the lab in November of 2015 Ershigs switched to a carbon treatment media to replace the zeolite media. See Attachment C, Photo #3.

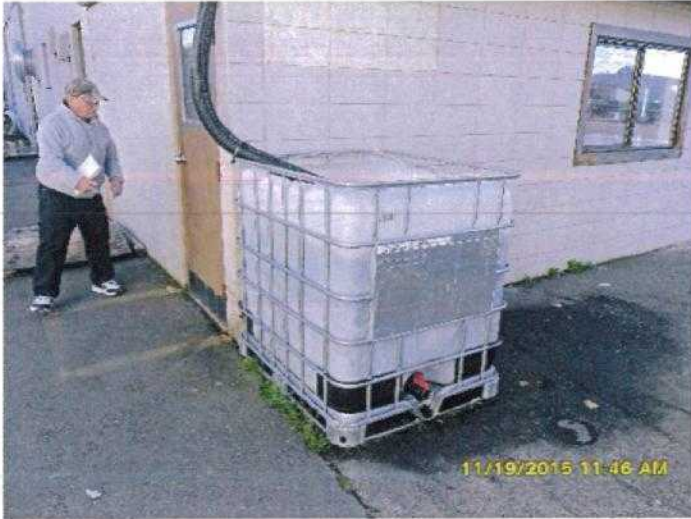
Photo #:05

Description: View of another Grattix treatment system at the facility. This system was installed in 2014 and is used to treat roof runoff from another building at the facility. Camera photo # SAM 2228.

- Installation of Grattix bio-filtration systems on roof drain downspouts. In July of 2013 Ershigs installed a Grattix system to the roof drain downspout from the assembly building. With initially a reduction in Zinc levels, Ershigs purchased 6 additional Grattix systems in January/February 2014 to filter rainwater runoff from downspouts along several metal roof buildings. See Attachment C, Photo #4, #5 and #6.

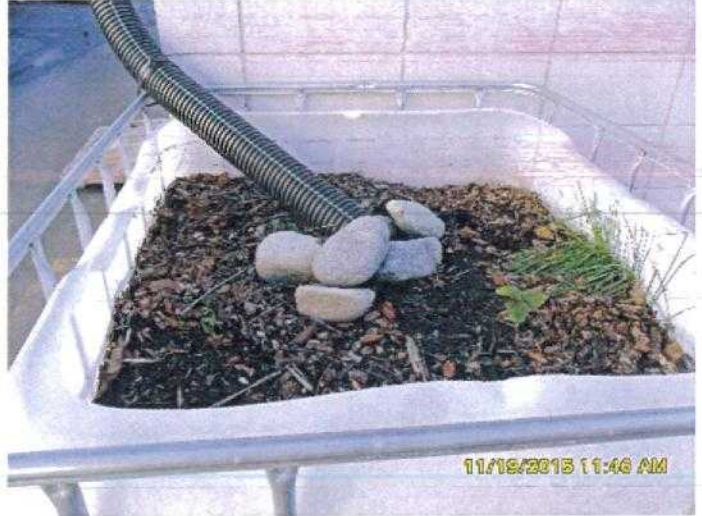
Photo #:06

Description: Close-up view of the Grattix treatment system shown in the previous photograph. Camera photo # SAM 2229.

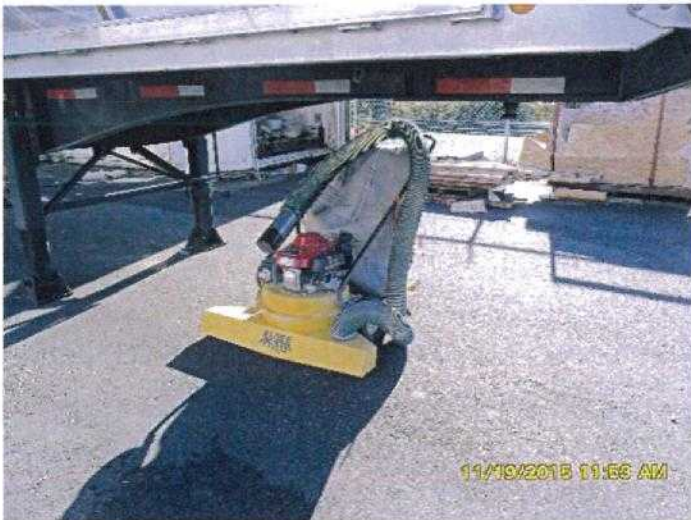
Photo #:07

Description: View of small vacuum sweeper used to clean outdoor pave surfaces at the facility. Camera photo # SAM 2233.

- Vacuum sweeping of paved surfaces. Ershigs purchased their own small sweeper in March of 2014 according to Mr. Strickler. High traffic areas are swept sometimes 4-5 times a week on an as needed basis by Ershigs personnel. The company also contracts out quarterly sweeping from Whirlwind Services, Inc. See Attachment C, Photo #7.

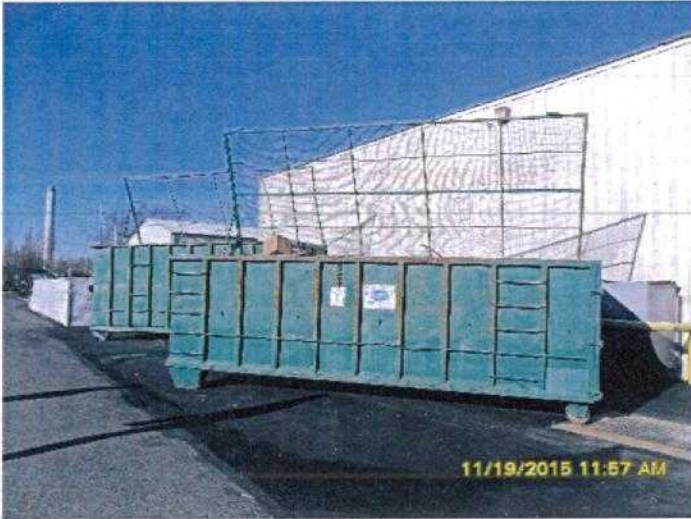
Photo #:09

Section S3.B.4.i.2.d. of the permit states that the permittee shall "keep all dumpsters under cover or fit with a lid that must remain closed when not in use."

At the time of inspection we observed a number of dumpsters at the facility, the two largest dumpsters located in the southwest corner of the facility did not have lids that would prevent stormwater from entering the dumpsters. See Attachment C, Photo #9, #10.

Description: View of two open dumpster located along the south side of the facility. Note that although these dumpsters did have covers, the covers consisted of a wire mesh material. Camera photo # SAM 2235.

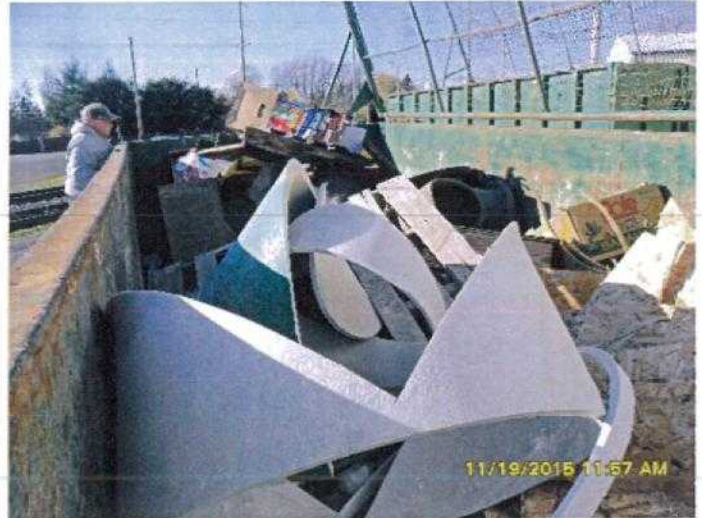
Photo #:10

Description: View inside one of the two open dumpsters shown in the previous photograph. Camera photo # SAM 2236.

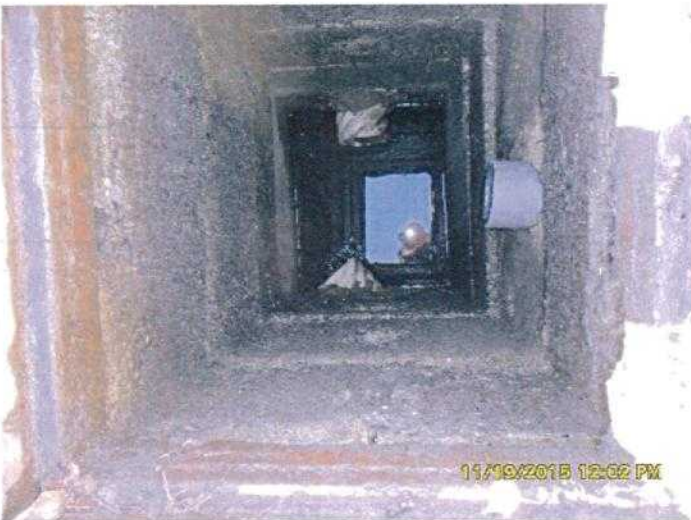
Photo #:11

According to the facility DMR's, in the past 5 years (or 20 quarters), the discharge from SD-15 has exceeded the benchmark value for Zinc in 11 quarters and exceeded Turbidity in 11 quarters.

Description: View inside sample point SD-15. Camera photo # SAM 2238.

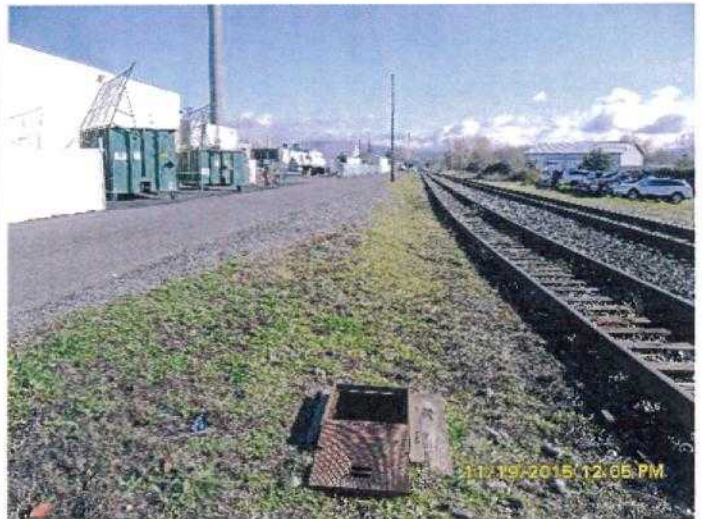
Photo #:12

According to the facility DMR's, in the past 5 years (or 20 quarters), the discharge from SD-2 has exceeded the benchmark value for Zinc in 15 quarters.

Description: Easterly view along the south side of the property. Note the location of sample point SD-2 in the foreground. Camera photo # SAM 2239.

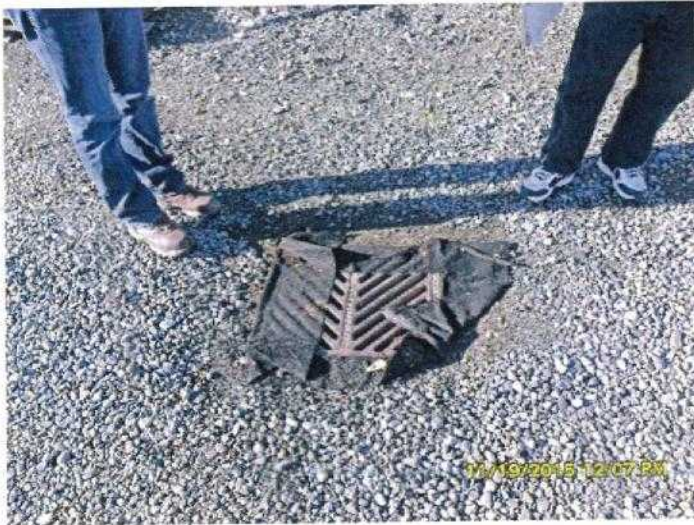
Photo #:13

Description: View of one of the catch basins located in the graveled area in the northwest portion of the property. According to Mr. Strickler, drainage entering this catch basin is routed through sample point SD-15. Camera photo # SAM 2241.

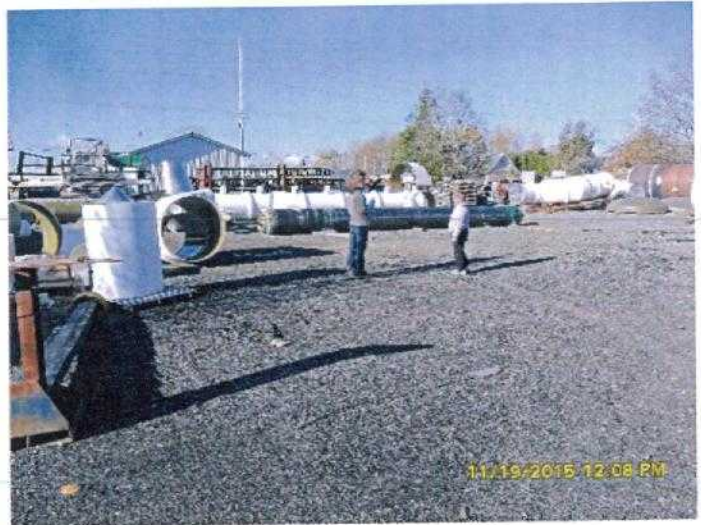
Photo #:14

Description: Northwestern view of the graveled area located in the northwest portion of the property. Drainage in this area is routed through sample point SD-15. Camera photo # SAM 2242.

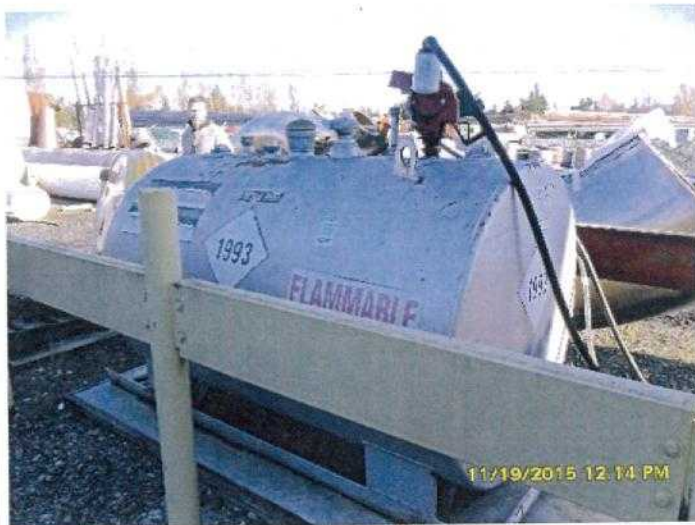
Photo #:15

Description: View of the fuel tank located in the graveled area (or northwest portion) of the facility. Camera photo # SAM 2246.

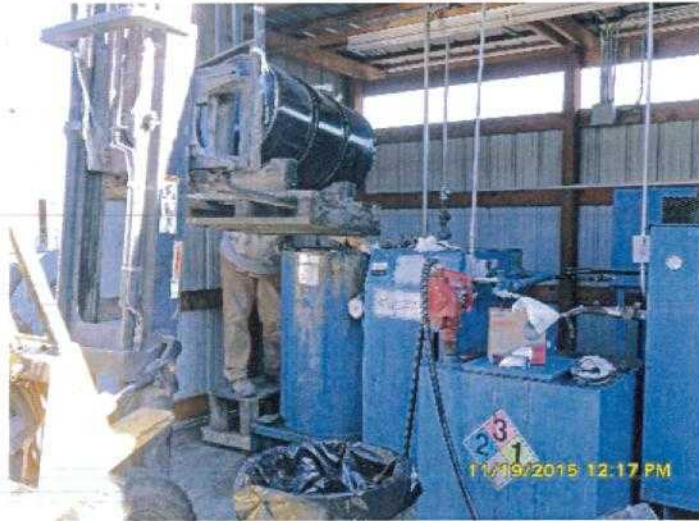
Photo #:17

Section S3.B.4.b.i.4.a. of the permit states that the permittee must "store all chemical liquids, fluids, and petroleum products, on an impervious surface that is surrounded with a containment berm or dike that is capable of containing 10% of the total enclosed tank volume or 110% of the volume contained in the largest tank, whichever is greater.

At the time of the inspection, we visited the DAA Distillation Area where DAA is recycled for reuse. The distillation unit is under cover, however they lack secondary containment. Staining was also observed on the paved area around the unit. SD-13 is located downslope and approximately 80ft away from DAA Distillation Area. See Attachment C, Photo #17, #18 and #19.

Description: View of the solvent still. The individual in the photograph is dumping spent solvent into the still. Camera photo # SAM 2250.

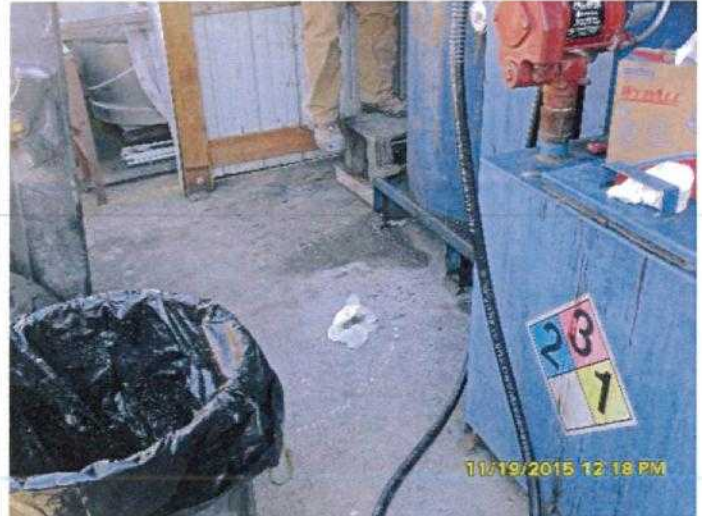
Photo #:18

Description: View of the ground surface in the vicinity of the solvent still. Note the staining on the ground. Camera photo # SAM 2251.

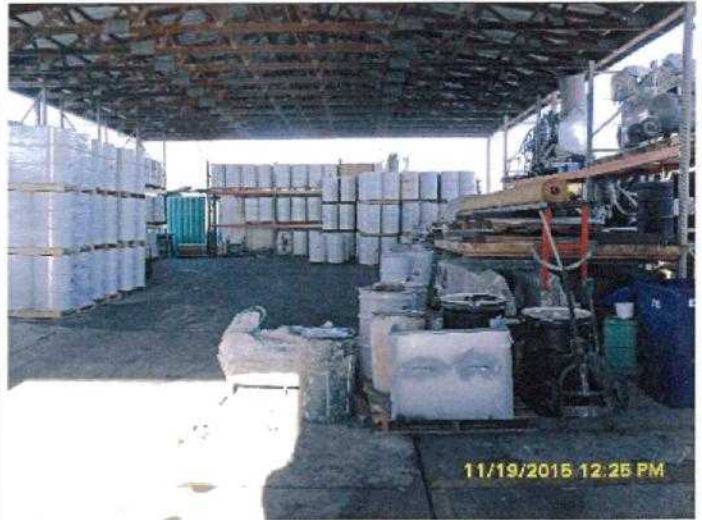
Photo #:20

Description: Northerly view inside the resin storage building. Camera photo # SAM 2254.
